OKTAHTA

Pipe inspection complex - HeatScan

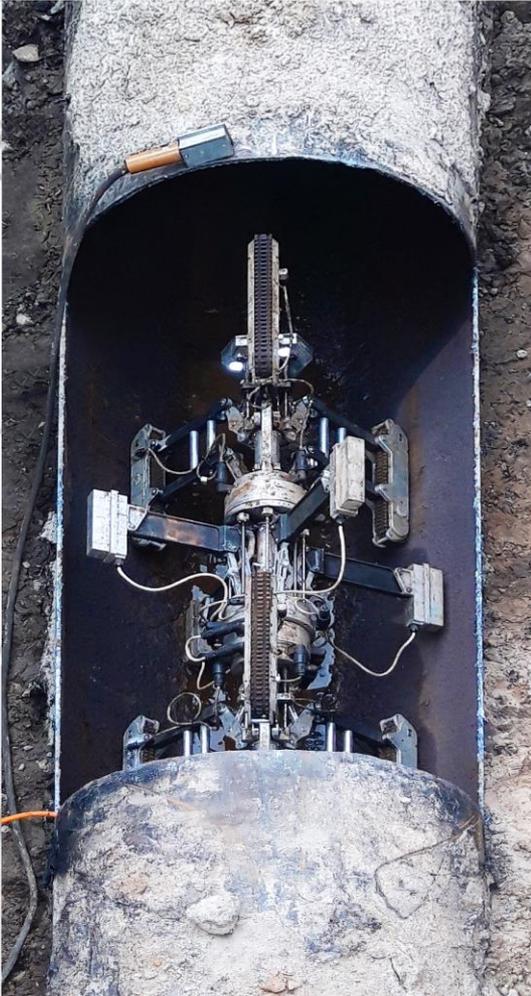
The complex is designed to detect defects in pipelines using an in-line diagnostic robot and assess the residual life of defective sections.

The technology does not require preliminary preparation of the pipe, it allows you to control the state of the metal through a layer of deposits up to 30mm.

The diagnostic robot of the complex is equipped with six tracks, allowing to pass areas with a significant level of pollution.

The robot is controlled by an operator located inside the autolaboratory - the mobile control panel of the complex, at the place of loading the robot into the pipe. Loading takes place through a technological cut of a pipe measuring 400x600mm. The total number of operating personnel is 2 people.

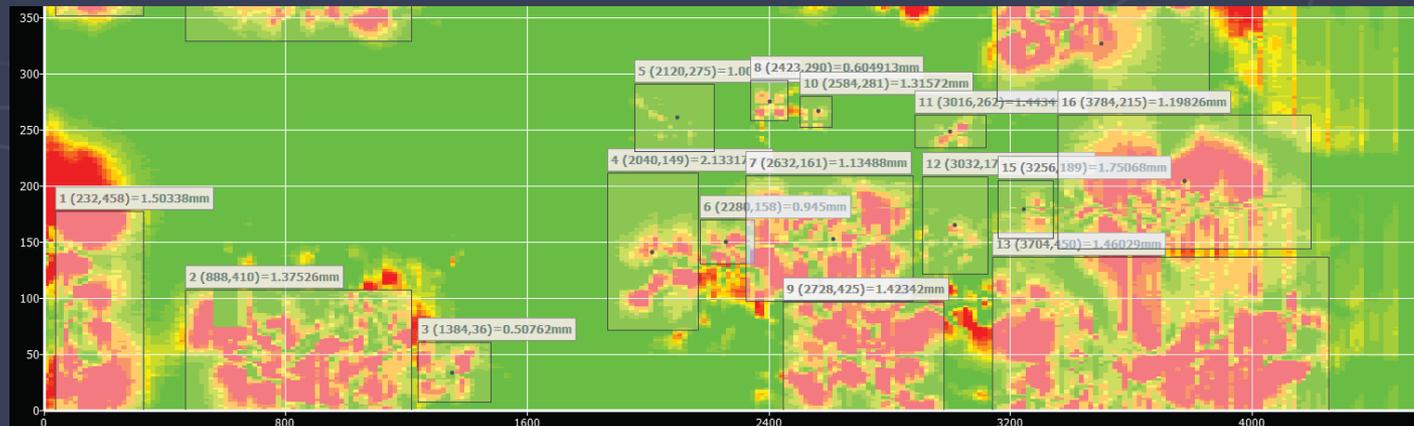
Using special software, the operator generates a report on the technical condition of the area being inspected, indicating the coordinates and sizes of the defective areas. An example is below.

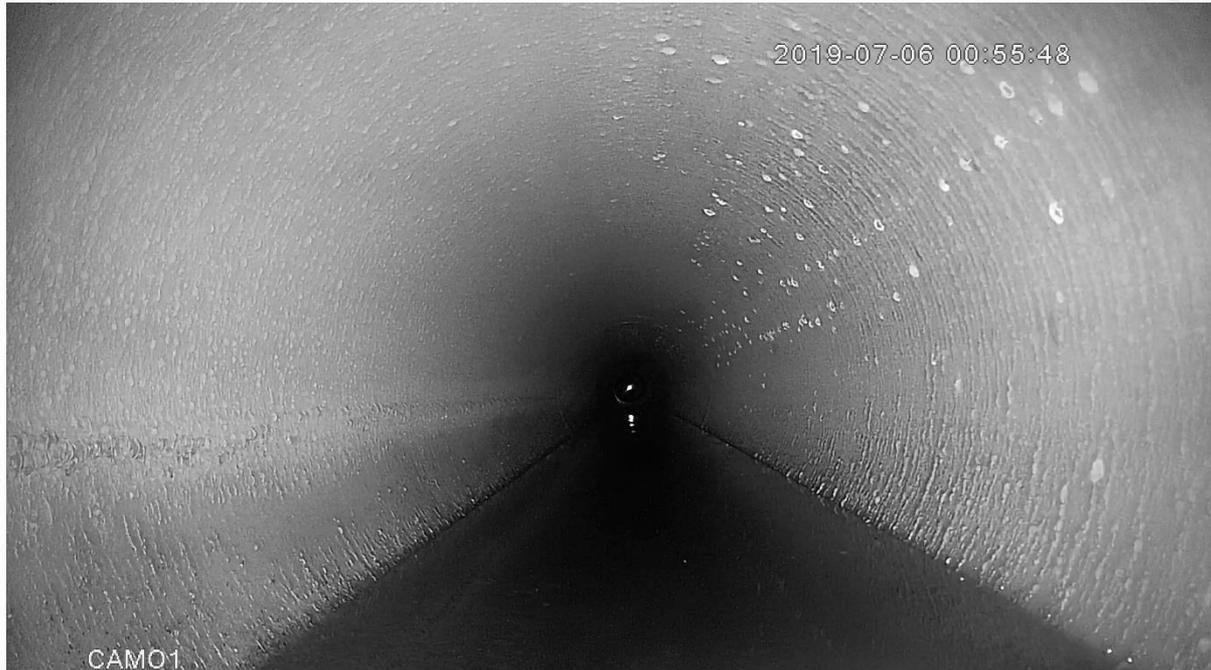
Heatscan complex consist of:

- Auto mobile laboratory
 - Complex control panel
 - Probing current generator
 - Power supply cable 500 m
 - Gasoline Generator
- Robotic inspection module
 - Two movement modules - crawlers
 - Measuring module

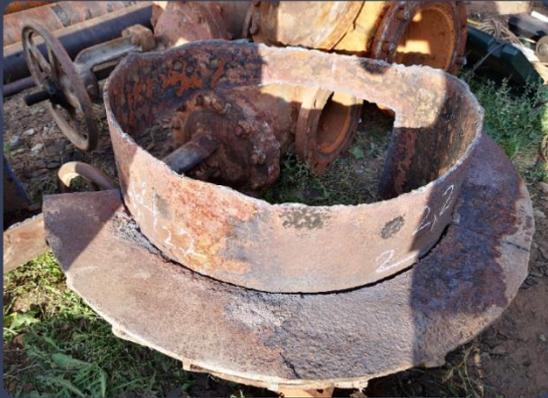
A defect in a motionless support, thinning more than 70%

In 2019, the Heatscan complex carried out diagnostics of heating networks in several cities of Russia. Below are example of defect that was discovered by Heatscan complex

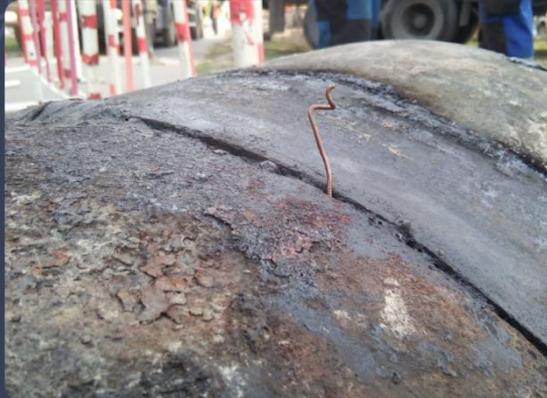
Poorly welded seam

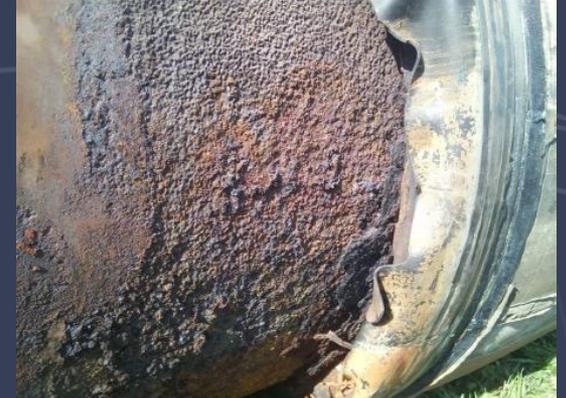
Heavily corroded zone under isolation

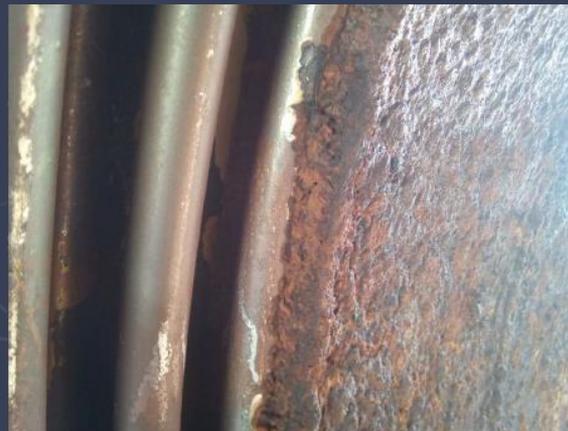
A defect discovered in expansion joint area
